# Concrete Step Barrier Design Guidance

## CSB: Conforming to BS EN 1317

### Design Guidance Notes

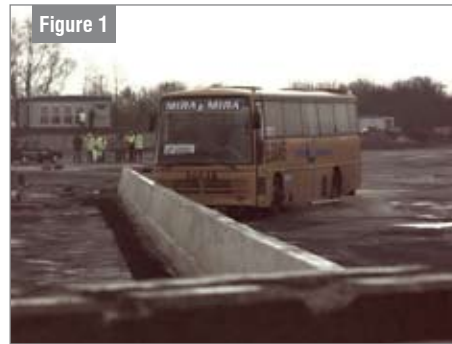
Figure 1  
TB51 test showing 13t bus at 70kph approaching CSB at 20°

When CSB is subjected to a TB51 test (Figure 1), CSB contains the vehicle and re-directs it along the face of barrier in the same direction as the traffic flow (Figure 2).

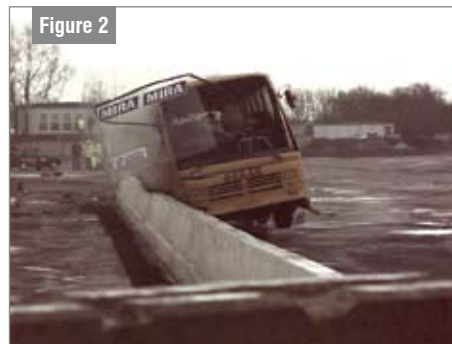
Figure 2  
TB51 test showing 13t bus after impact with CSB

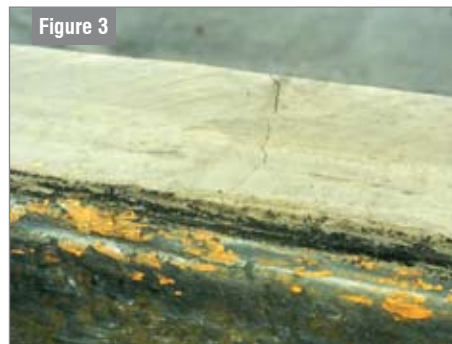
Figure 3  
CSB following TB51 test

Under test conditions, CSB sustains minimal damage on impact (Figure 3); the barrier continues to be serviceable and provide containment, even after the TB51 test.

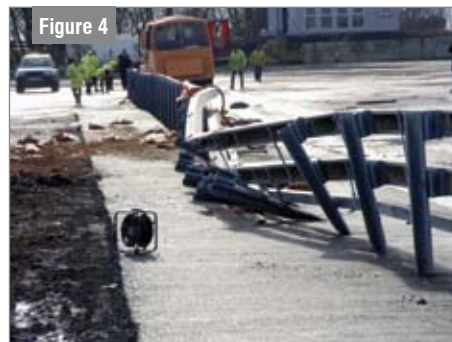
Figure 4  
A deformable steel safety barrier following TB51 test

This contrasts with deformable steel safety barrier products, which are severely damaged during the TB51 test (Figure 4) and require replacement even after the TB11 car impact.
